MOISTURE PLUS
PH CAN ADD UP
TO FLOORING
FAILURE

CAUSTIC COMMENTS

BY BILL IMHOFF

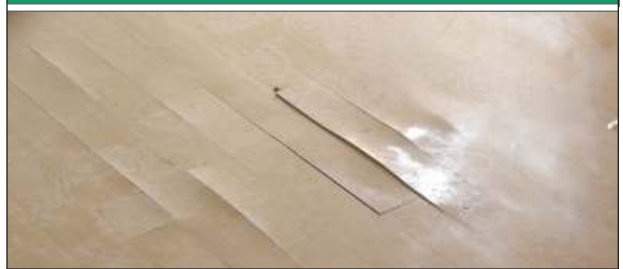
Wouldn't stay down

Figure 1. Moisture and pH problems led to strip failure, stressed vinyl composition tile and efflorescence in the seams.

In Austin, Texas, a manufacturing facility struggled for 15 years with tile failures from moisture and high pH. It spent \$250,000 to remove failed floor tile and encapsulate the slab with a moisture barrier to install a warrantable floor covering that provides 2,000-psi strength for the massive machinery that moves across this floor (Figure 1).

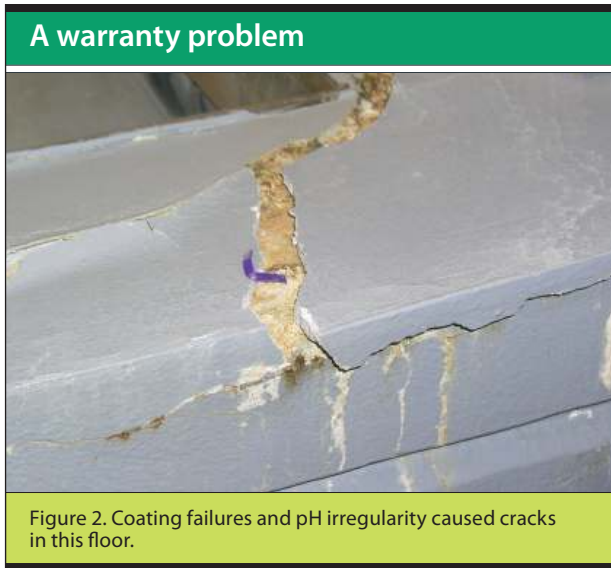
A warranty problem

Figure 2. Coating failures and pH irregularity caused cracks in this floor.

Balancing slab pH and moisture level can be challenging and costly. Concrete has a naturally high pH. But, many flooring manufacturers won't warranty installations if the pH is at natural levels, even though moisture is low (Figure 2). Nationwide, moisture and pH-related flooring problems have reached the billion-dollar level annually, according to independent concrete flooring expert Scott M. Tarr, principal engineer at CTL Group, Skokie, Ill. Factors driving these problems include:
